ENGINEERING, FEASIBILITY AND ECONOMIC ANALYSIS STUDY OF METRO-NORTH RAILROAD BRIDGE OVER THE HOUSATONIC RIVER (DEVON BRIDGE)

Bridge No. 08080R, M.P. 60.42
State Project No. 301-099

Submitted by:
Stantec Consulting Services Inc.

December, 2010

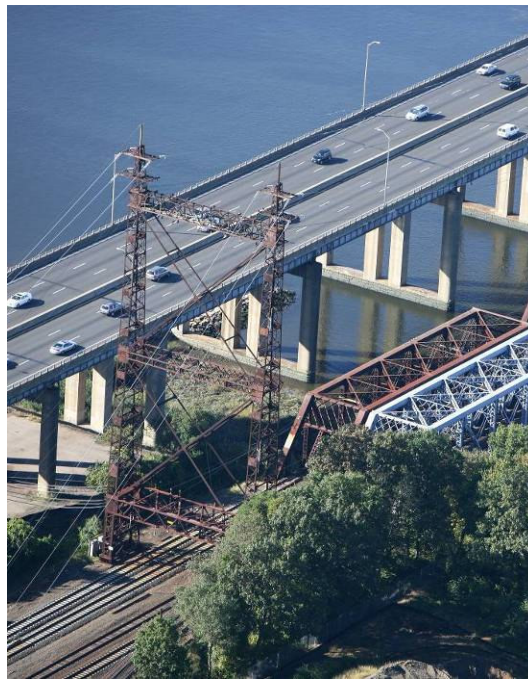
Photo I-3: High Tower at East Approach

The high towers are in poor condition. At the end towers (862 and 863), all legs have section loss up to ½ inch deep on the interior sides of the angles along the edges of vertical gusset plates at the splices, and cover plate loss up to 90%, typical at splices with thin shim plates. The horizontal bracing members at lower elevations have extensive section loss at isolated locations. The section loss is typically at the member connections. The gusset plates at the horizontal member connection typically have section loss up to ¾ inch deep along the top of the horizontal member. There are isolated gusset plates that have section loss around all sides of the horizontal member. On the middle tower (862A), the only sizeable section loss to the leg angles is on the tower legs at the base. The bracing and lacing bars also have section loss at the concrete encasement interface with up to 100% section loss on isolated members. The anchor bolts are in poor condition, with section losses up to nearly 50% at some locations.

For Alternatives III and IV, the existing high towers carrying high voltage feeder lines will be replaced with new monotube towers.

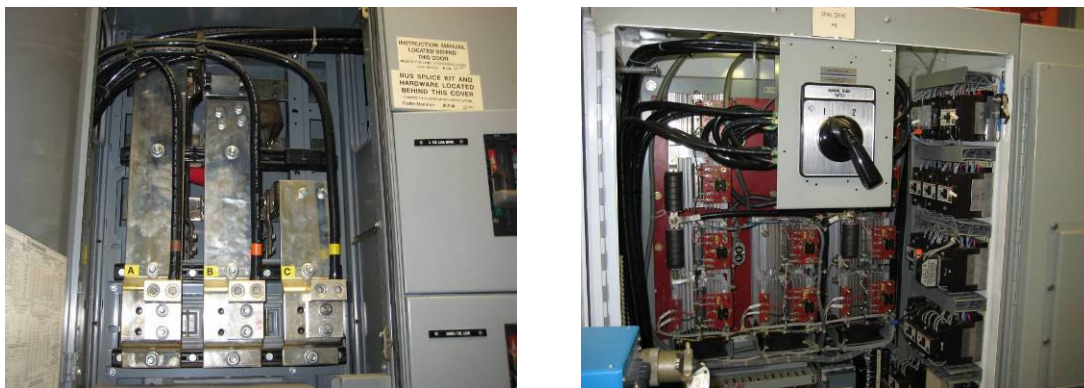
The automatic transfer switch is in good condition, but its automatic operation is disabled as there is no alternate power source.

Photos IV-14 & IV-15: Incoming service panel (L), and Span motor drive crossover switch (R)

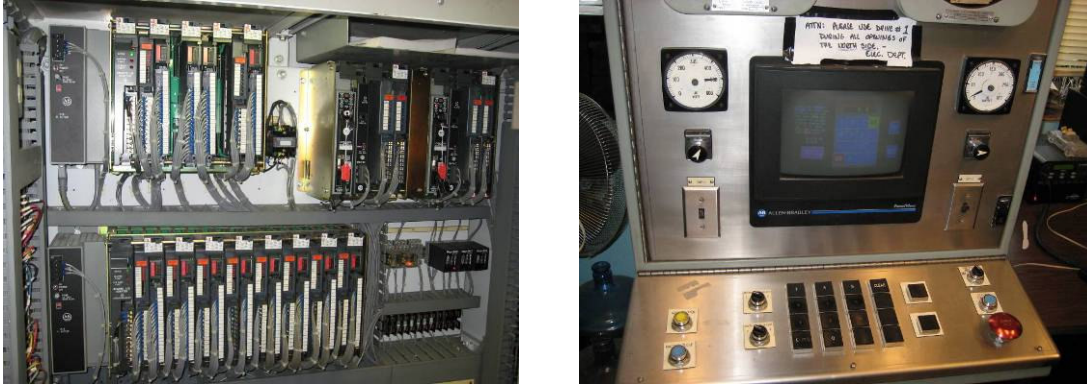
Photos IV-16 & IV-17: PLC (L), and control console (R)

The control console is located in the operator's room of the operator's house. The console equipment is fully functional. Position indications are accurate and show zero with the leafs seated. The voltmeter and ammeter are in good condition but the ammeter requires recalibration.

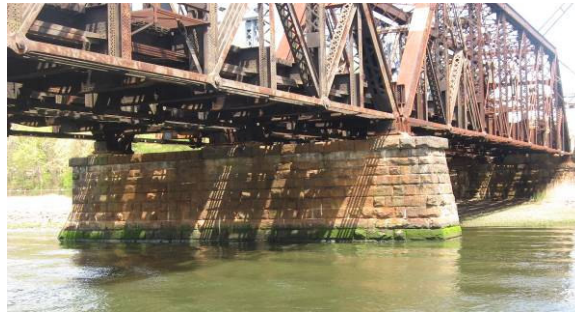
Photo VIII-1: Typical Pier

The existing bridge is supported by two gravity type masonry abutments founded on spread footings, with six intermediate piers constructed of masonry with deep concrete foundations founded on spread footings. The abutments are labeled Abutments 1 and 2, from west to east. The piers are labeled Piers 1 through 6, again from west to east.

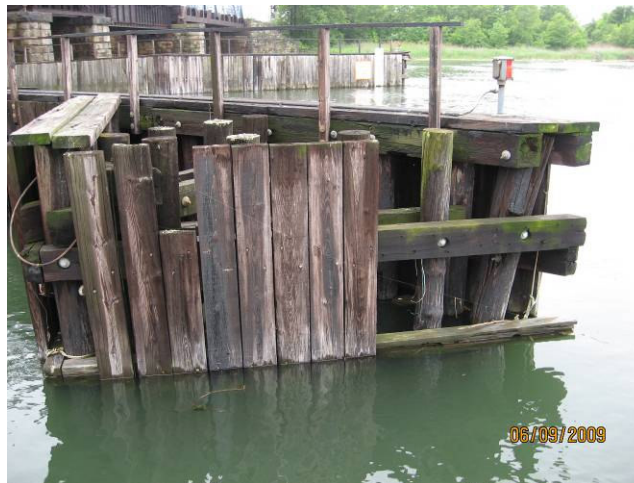
Photo VIII-2: Fender System

A timber pile supported fender system protects Piers 3 and 4, which are adjacent to the navigation channel below movable Span 4.
